# Manhole Inspection Summary

Manhole # S13QQ\_032MH

Record Plat: **13QQ** Node: **032** Status: **Other (Specify in comment)** Insp Date: **7/22/09 10:13 AM**

**Location** Address: **2700 DUKELAND ST**

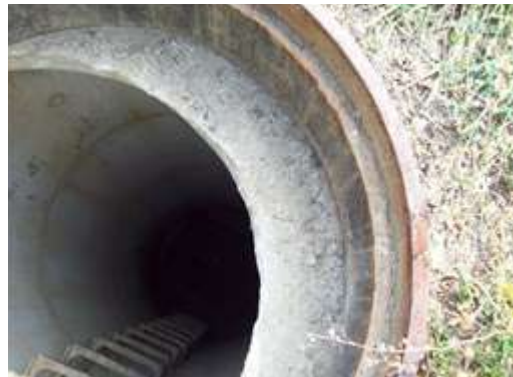
Defect 1

**Frame** Offset: **5** (in.) Condition: ☒ Sound ☐ Cracked ☐ Leaks

OFFSET FRAME

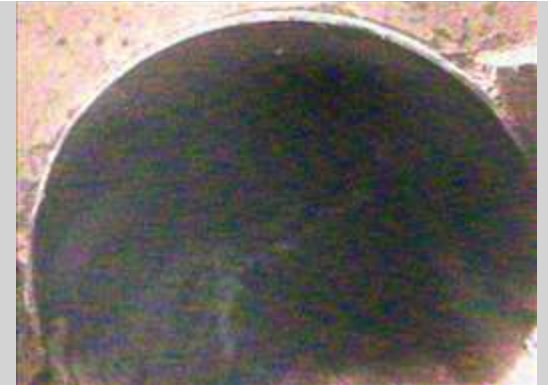
12 O'Clock Outflow

20 in. Circular Gravity Sewer  
Pipe Out @ 12 O'Clock

Pipe Material: **DIP/CI** ☐ Pipe Lined

Invert Depth: **19.95** (ft.) Flow Characteristics: **Fast**

Deposits: ☒ None ☐ Mud ☐ Sludge ☐ Debris ☐ Grease

Infiltration: **None** Pipe Seal Cond: **Sound**

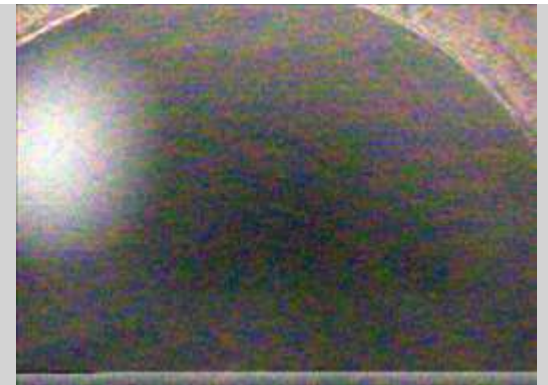
6 O'Clock Inflow

20 in. Circular Gravity Sewer  
Pipe In @ 6 O'Clock

Pipe Material: **DIP/CI** ☐ Pipe Lined

Invert Depth: **19.85** (ft.) Flow Characteristics: **Fast**

Deposits: ☒ None ☐ Mud ☐ Sludge ☐ Debris ☐ Grease

Infiltration: **None** Pipe Seal Cond: **Sound**
